CASE STUDY

BOEING 737-8200 MAX ELT System Installation

AFD Systems was engaged by EIRTECH (EASA Part21J DOA) to provide design support and stress analysis for the installation of an Emergency Locator Transmitter (ELT) system into BOEING 737-8200 (MAX) aircraft.

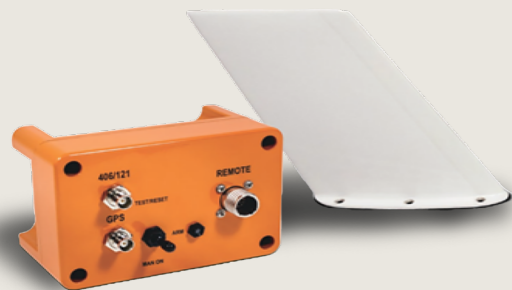
For the transmitter (orange item to the left), the loading is driven by worst case inertia conditions that encompass the crash, extreme manoeuvre, and gust conditions.

Both installations attach to and penetrate Principal Structural Elements (PSEs) that are also categorised as Fatigue Critical Structures (FCS). As such, it was necessary to carry out a fatigue and damage tolerance assessment of the affected parts.

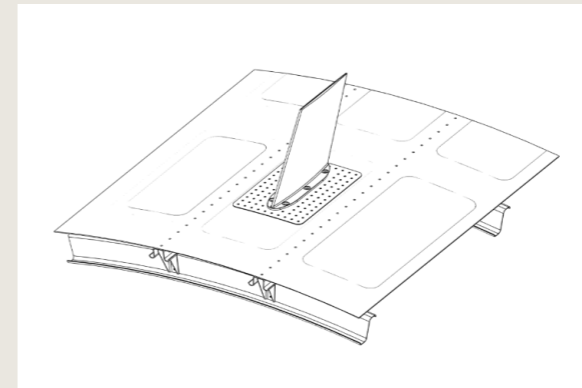
The design of the antenna installation was essentially split into two aspects: feed-through and doubler reinforcement; sub-structure intercostals for antenna base bending.

For the feedthrough, an external reinforcing doubler (riveted) was sized to return the original strength of the skin.

Considering the aircraft airspeed envelope, worst case lift and drag loads acting on the blade were derived. These loads were then transferred to the sub-structure intercostals and ultimately into nearby stringers.

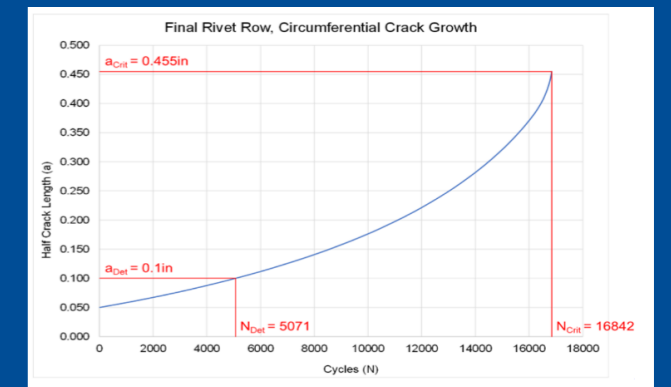
The damage tolerance evaluation for the antenna installation focussed on the skin penetration and riveted joints connecting the reinforcing doubler to the surrounding skin.

A traditional crack growth analysis was undertaken to determine threshold and repeat inspection intervals for the feed-through and final fastener rows in both the longitudinal and circumferential directions of the fuselage. Instructions for continued airworthiness (ICAs) were then published that defined both inspection methods and periods.
